# Wakendaw Farms Arborist Assessment

**Property Address:** 1455 Wakendaw Rd,  
Mt. Pleasant, SC 29464

ISA Certified Arborist SO-10727A

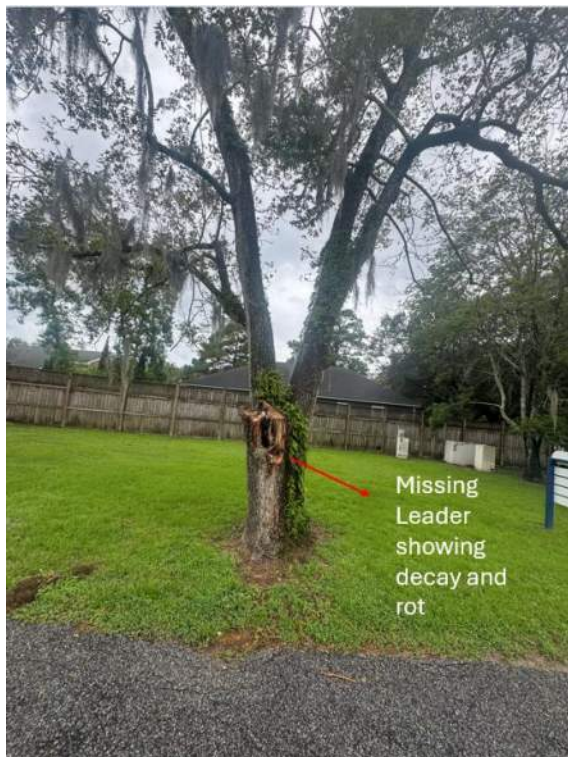
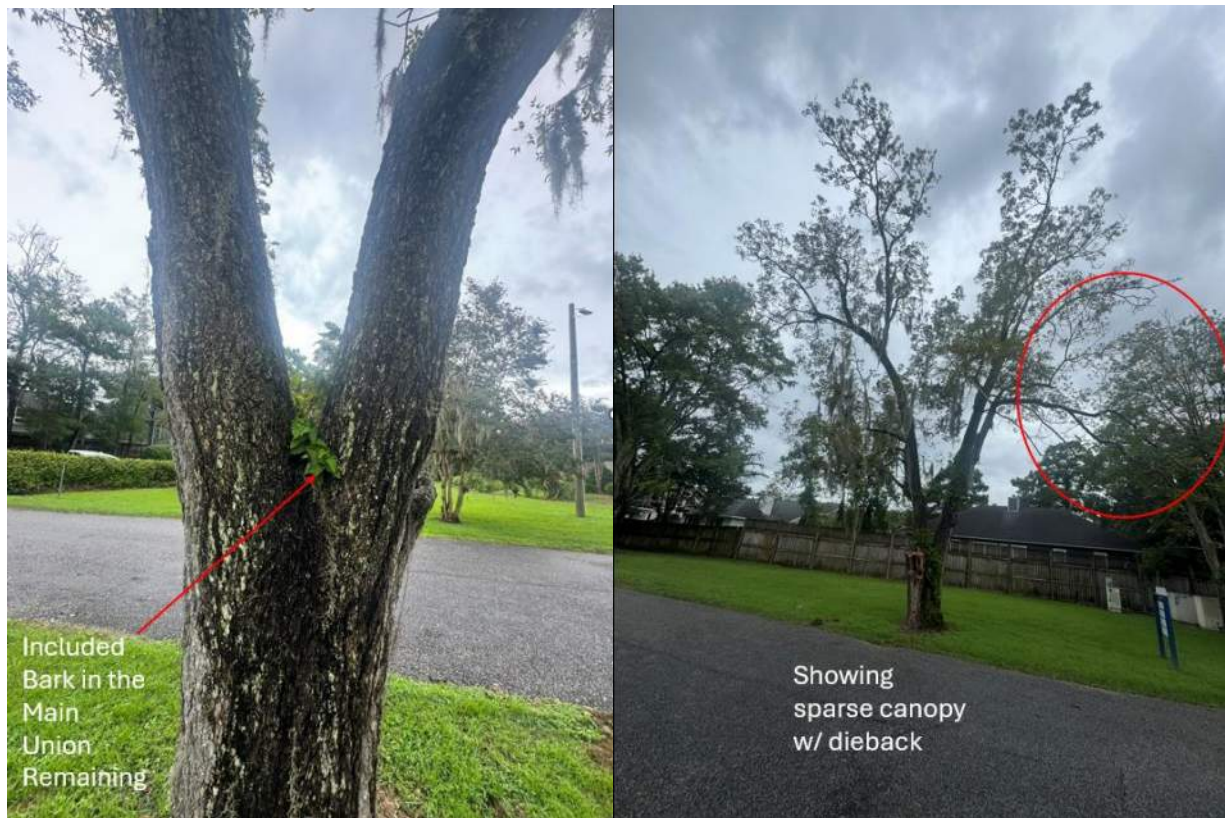
## Tree # 2

| Tree Number | Tree Size and Species | Condition | Notes | Historic? |
|---|---|---|---|---|
| 2 | 35" Pecan | Poor | Triple Leader/One Leader Failed/ Sparse Canopy/Included Bark | Y |

The pecan was in poor condition due to the previous failure of a significant leader that made up 25% of the Canopy. Where this limb failed, evidence of significant decay likely contributed, along with the included bark. The remaining wound cannot compartmentalize and will further cause rot and decay in the main union. The canopy is also showing signs of canopy dieback, which is expected after large limb failures.

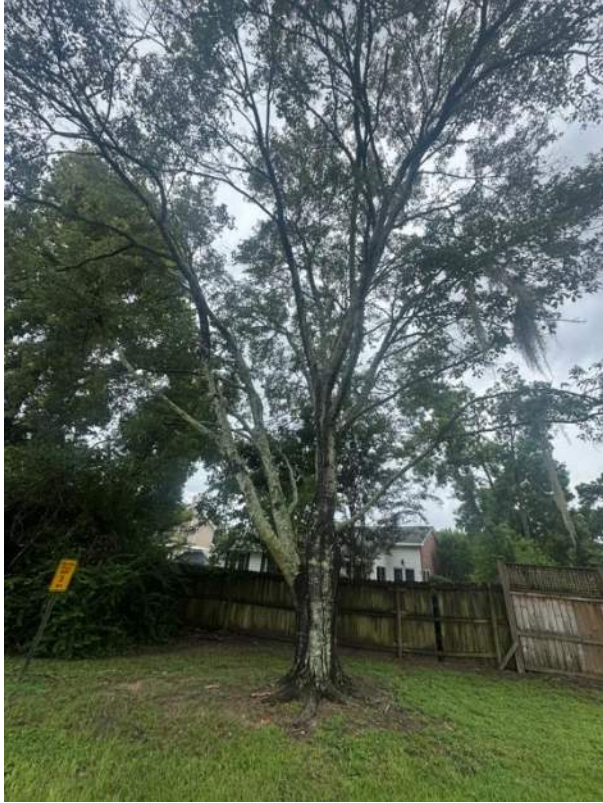
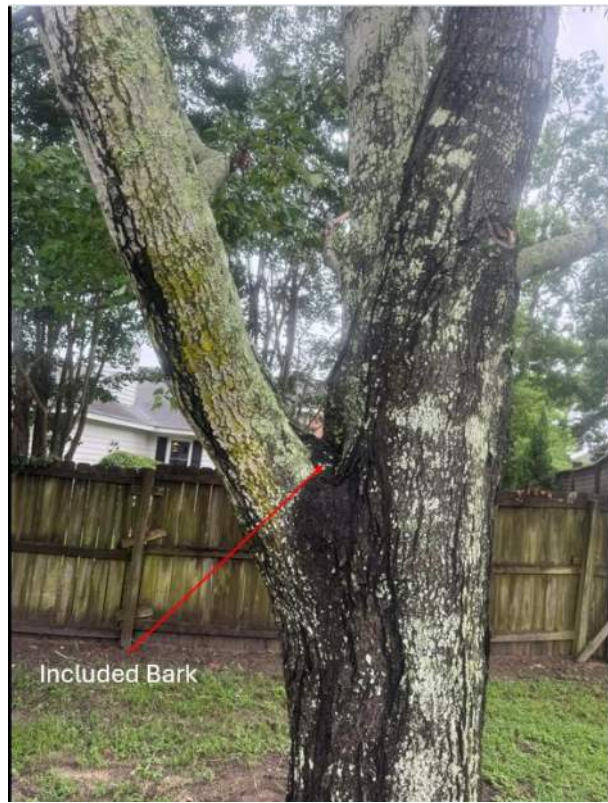
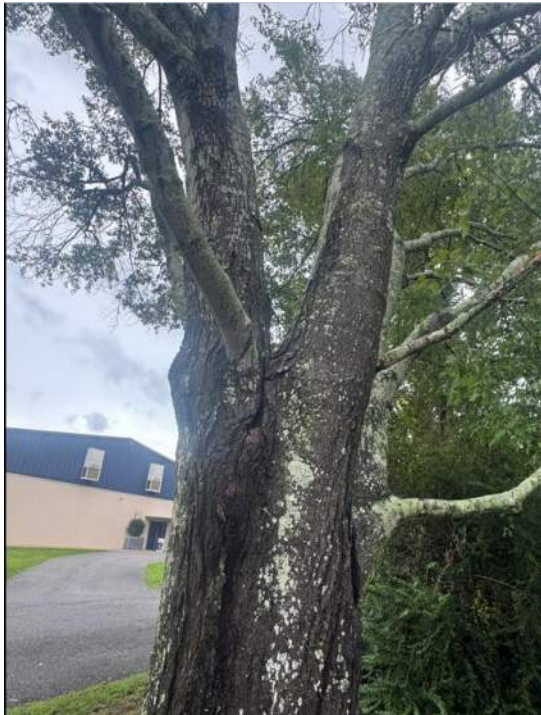
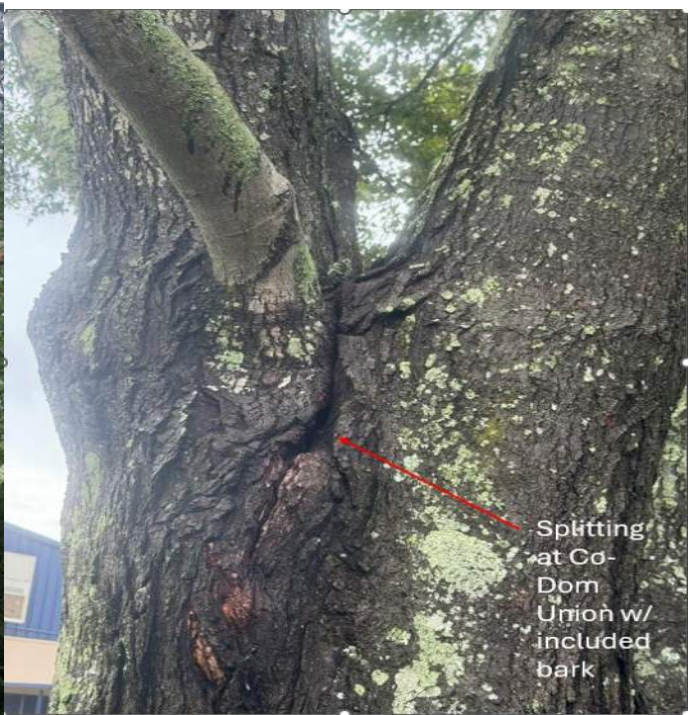
### Tree # 3

| Tree Number | Tree Size and Species | Condition | Notes | Historic? |
|---|---|---|---|---|
| 3 | 29" Red Maple | Poor | Co-Dom & Included Bark/ Splitting at Co-Dom Union | Y |

The red maple was found to be in 'poor' condition based on multiple large leaders containing included bark. One of the main unions was splitting during the time of inspection, which is expected in these circumstances. It's not feasible for an arborist to intervene at this point, once the tree has begun to split. Cabling would not eliminate the hazard presented.

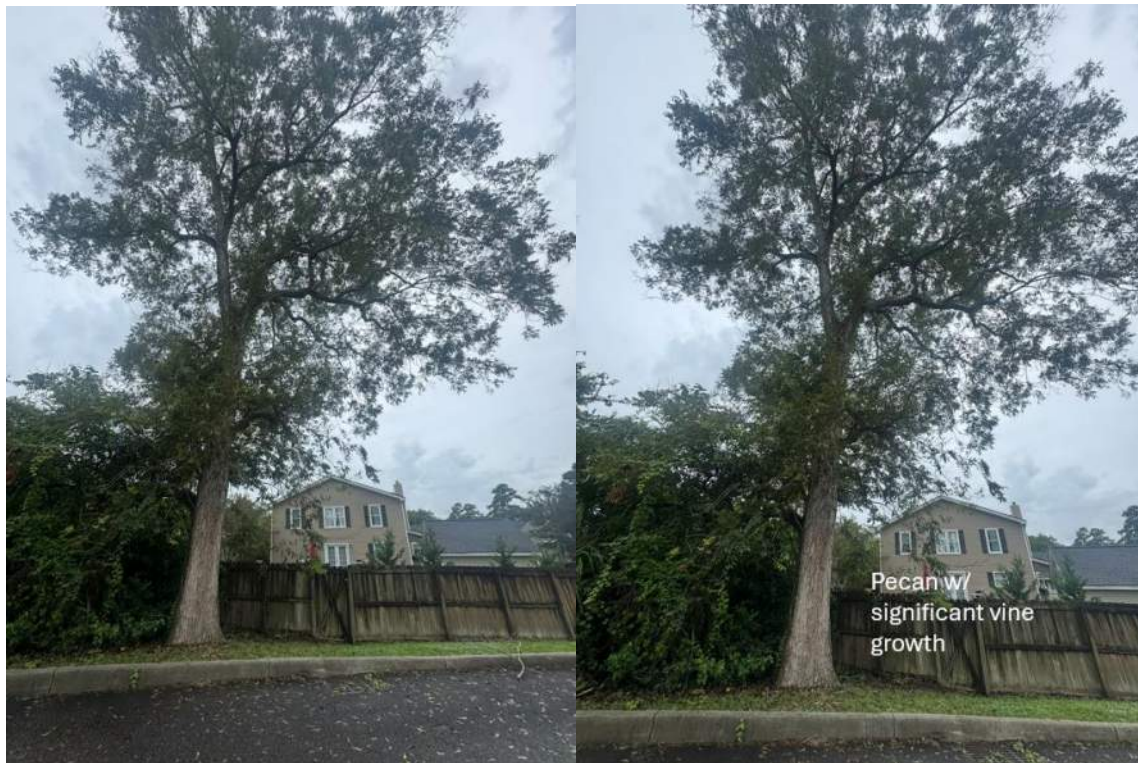
### Tree # 5

| Tree Number | Tree Size and Species | Condition | Notes | Historic? |
|---|---|---|---|---|
| 5 | 29" Pecan | Fair | Cavities through Stem/Vine Growth | Y |

Pecan was found to be in 'fair' condition, with some minor cavities through the stem and heavy vine growth that is contributing to added weight. Recommend removing vines to see further condition of the tree, and alleviate some weight on the limbs in the canopy.

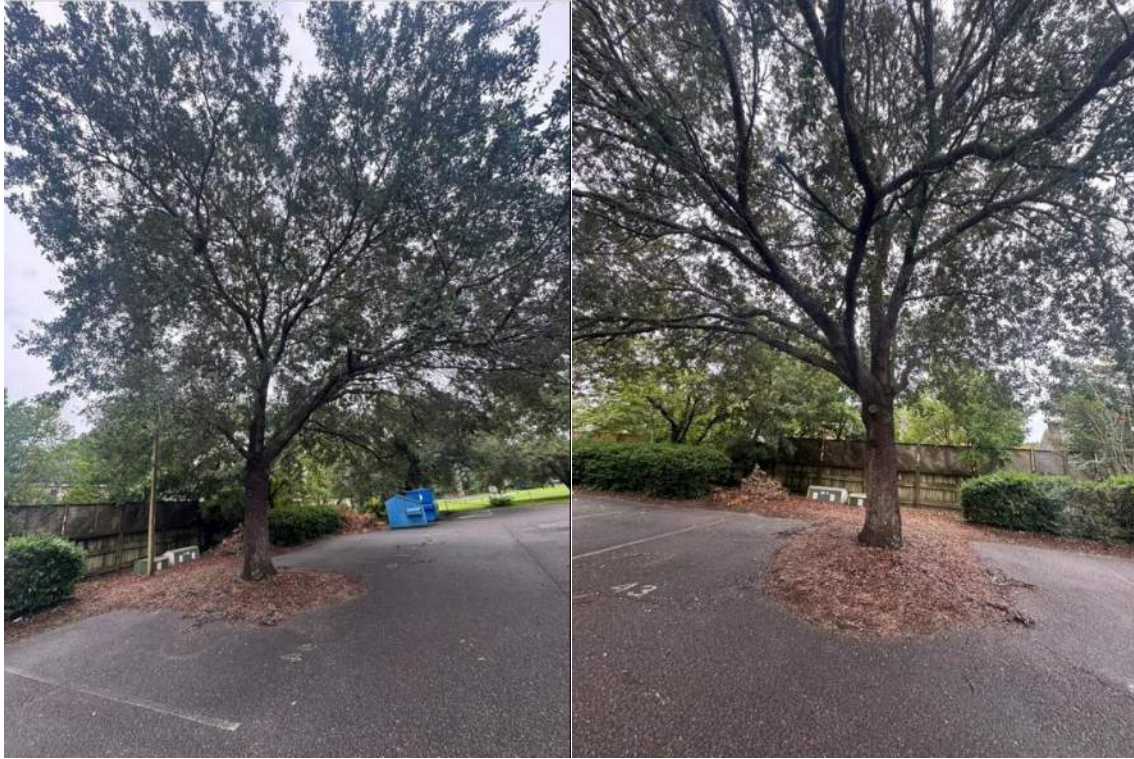
### Tree # 8

No structural defects were located on the Live Oak; it appeared to be in 'good' condition. The tree is currently on a parking island with limited room for future growth, with no substantial changes to the immediate site.

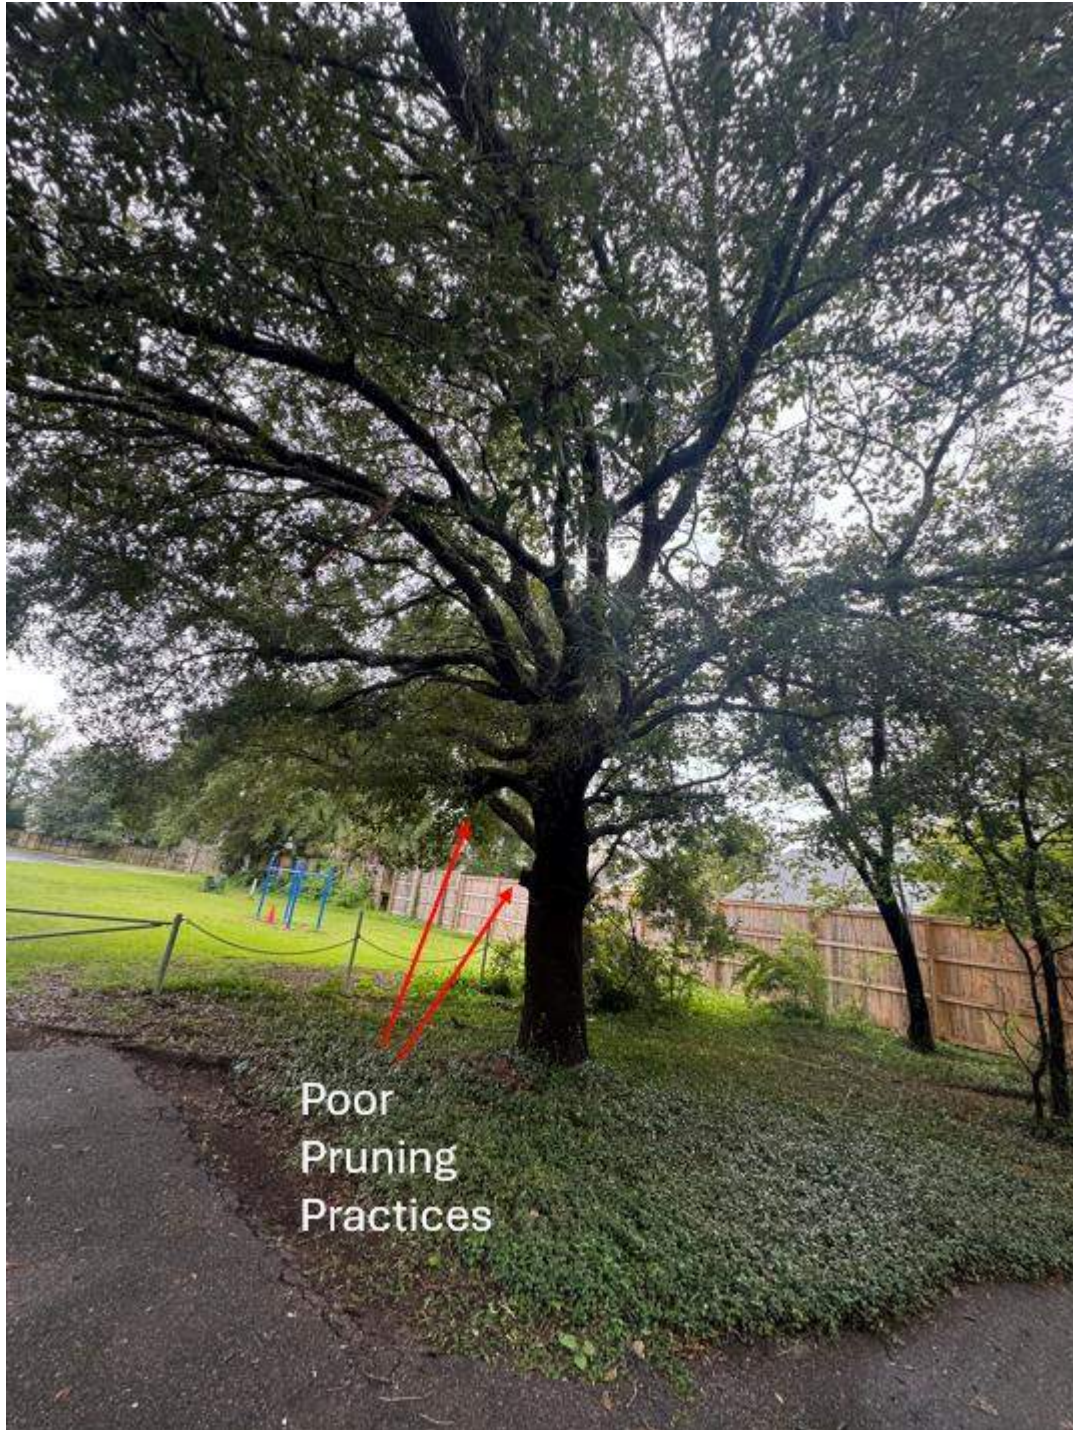
**Tree # 9**

| Tree Number | Tree Size and Species | Condition | Notes | Historic? |
|---|---|---|---|---|
| 9 | 24" Live Oak | Fair | Previous Poor Pruning Cuts | Y |

No structural defects were located on the Live Oak; it appeared to be in 'fair' condition, with evidence of poor pruning cuts made previously. These can be corrected as they're only stubs and can be cut back to appropriate ANSI Standards.

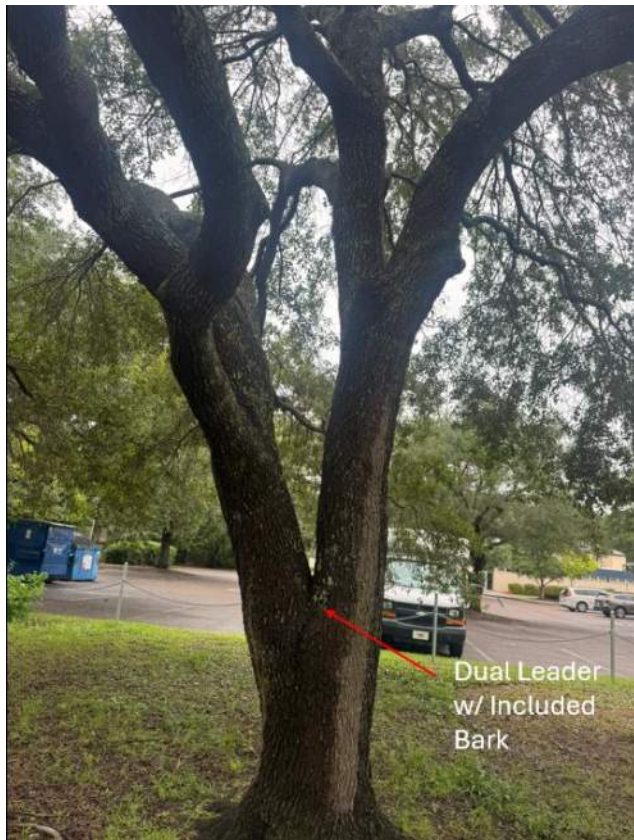
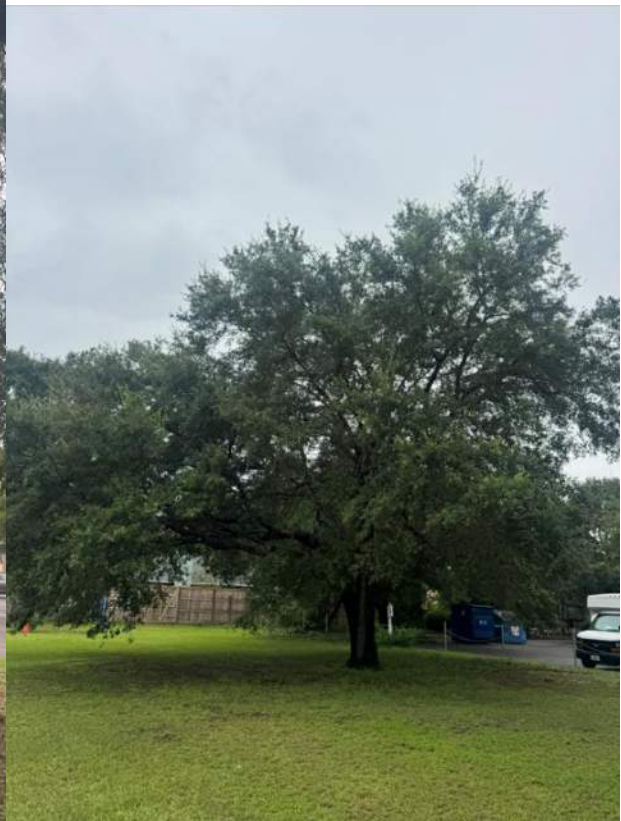
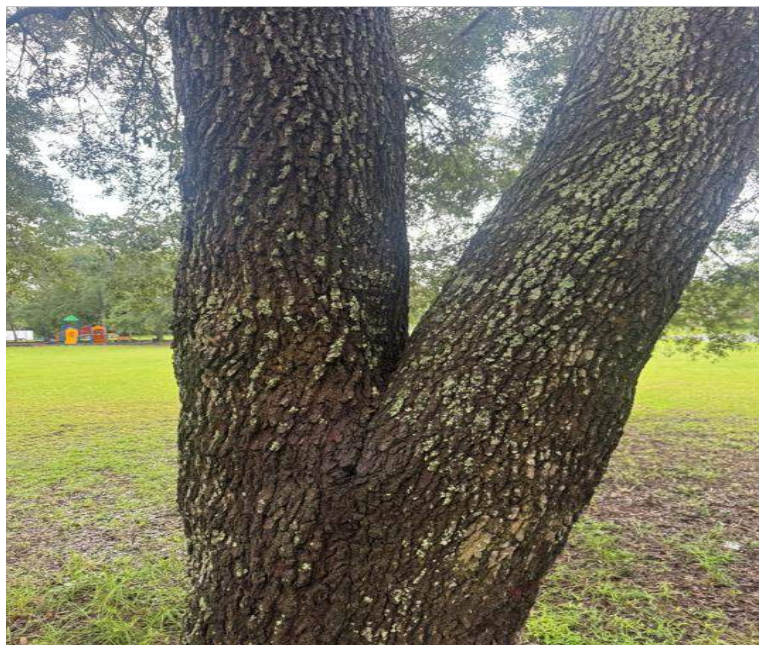
**Tree # 10**

Live Oak was found to contain included bark in the Co-Dom union.

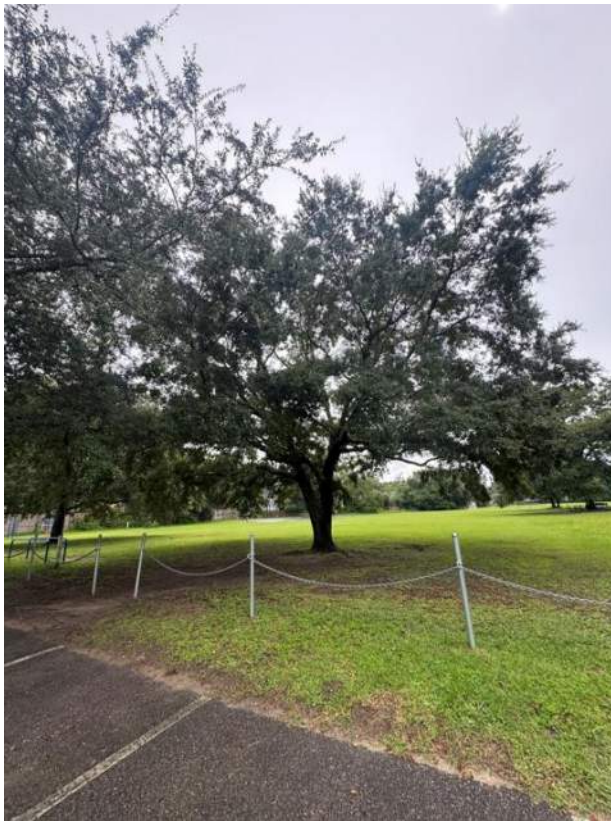
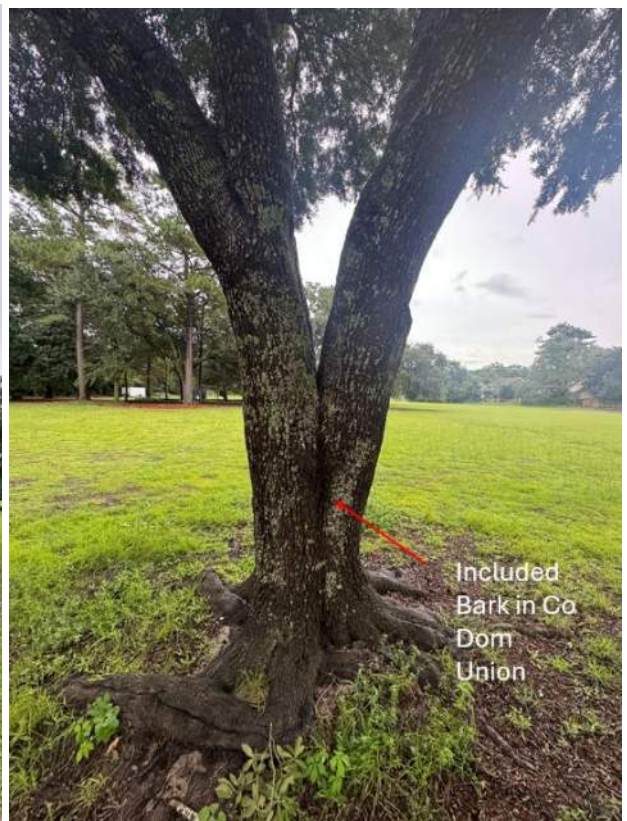
### Tree # 11

Live Oak was found to contain included bark in the Co-Dom union.

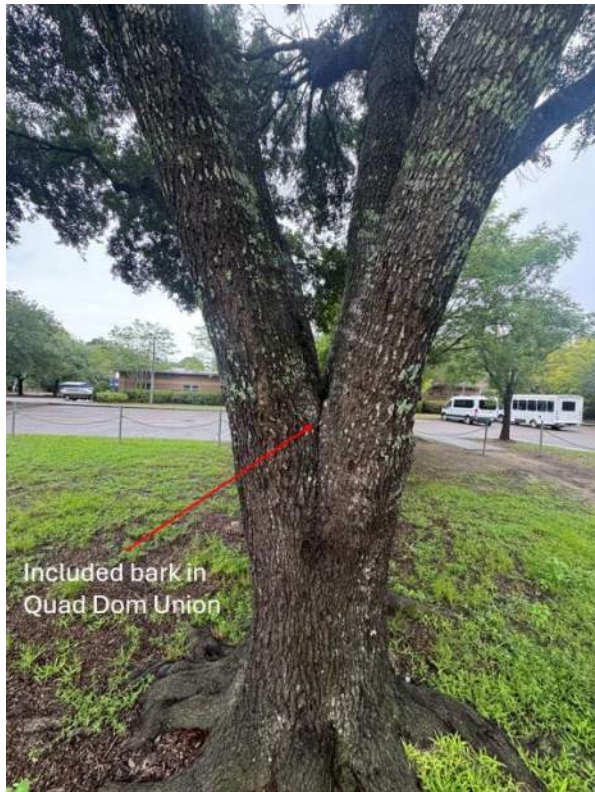
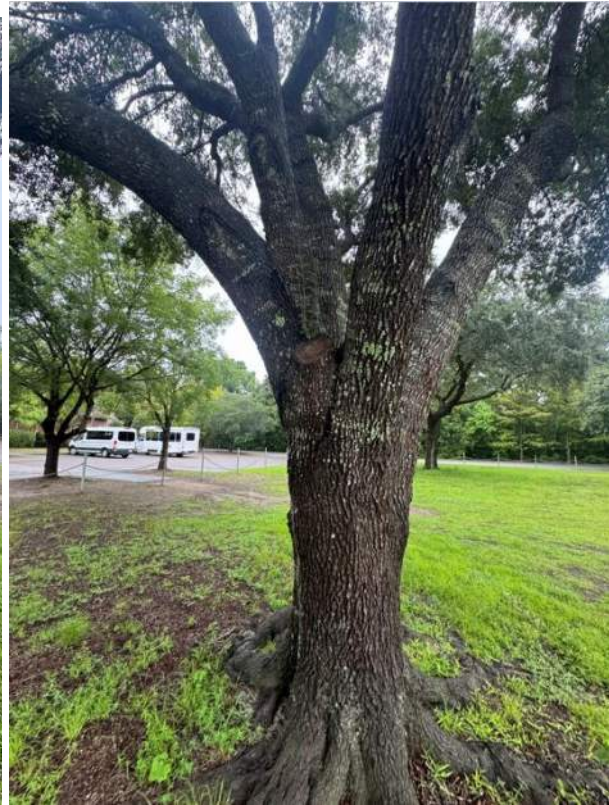
### Tree # 12

| Tree Number | Tree Size and Species | Condition | Notes | Historic? |
|---|---|---|---|---|
| 12 | 35" Live Oak | Fair | Included Bark/ Co Dom (Quad Leaders, with evidence of some decay in main union) | Y |

Live Oak was found to contain included bark in the Co-Dom union, which holds four large leaders together at this weak union.

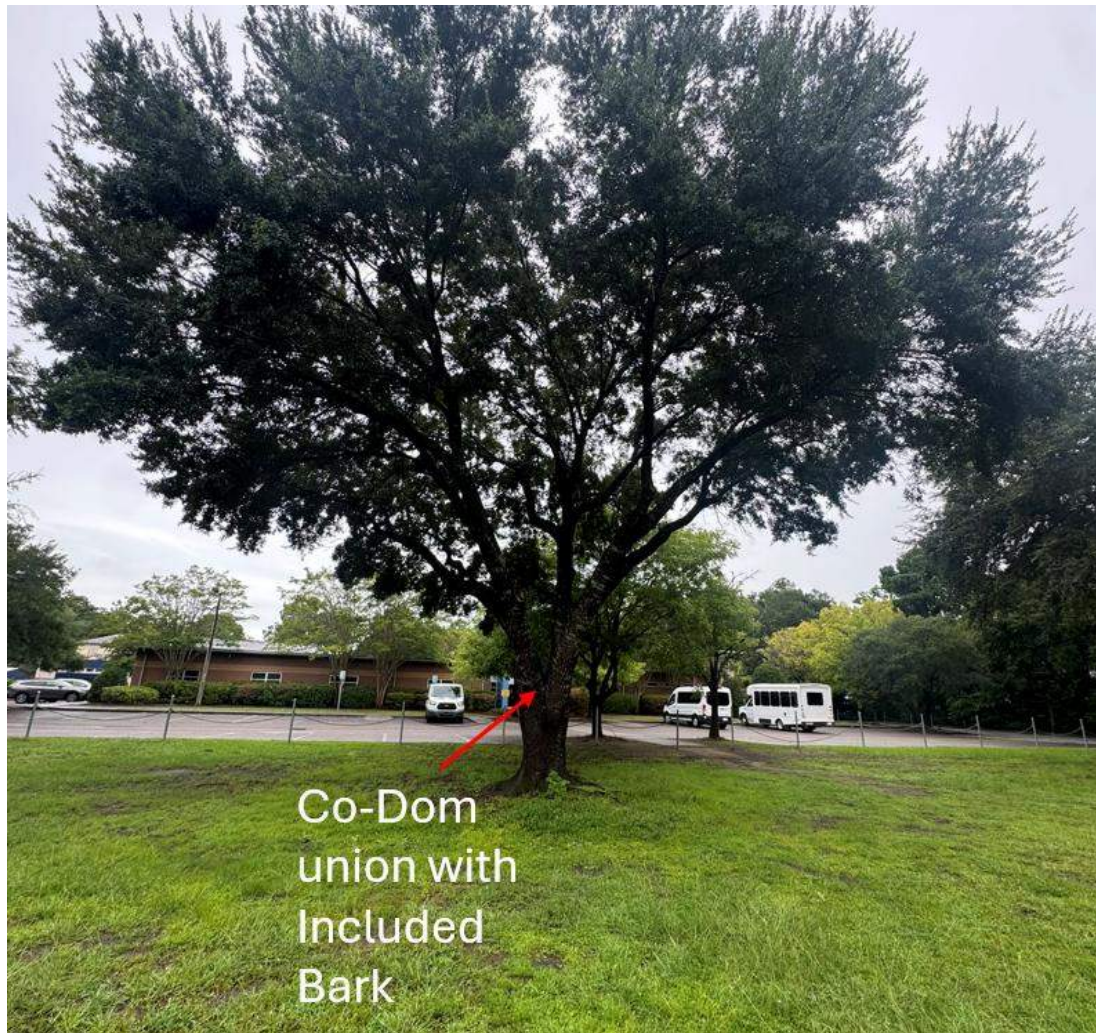
**Tree # 13**

Live Oak was found to contain included bark in the Co-Dom union.

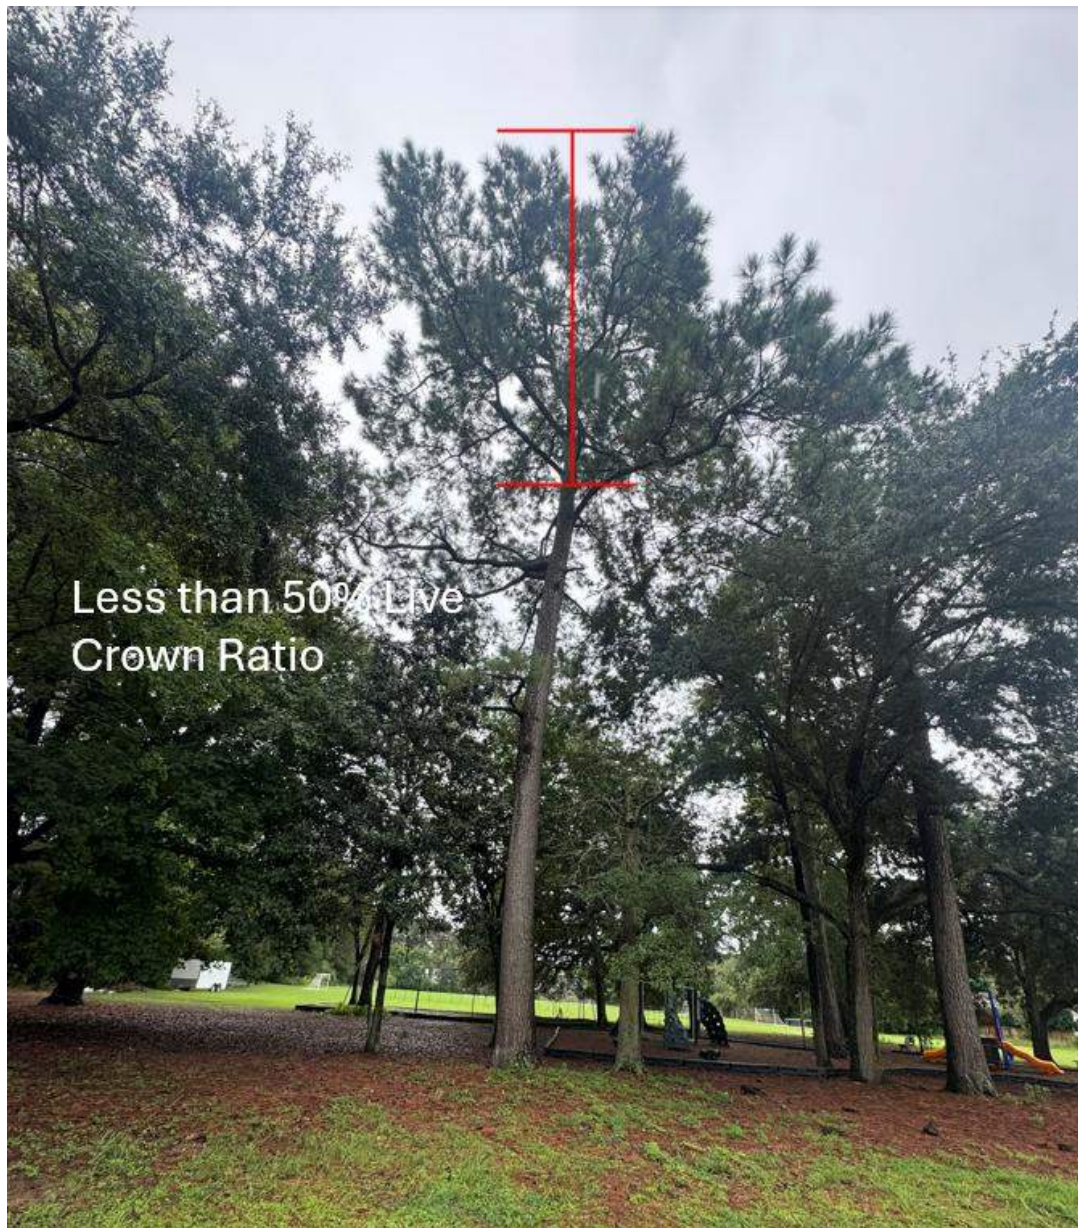
**Tree # 15**

Loblolly Pine was found to have a Live Crown Ratio lower than 50%, which is considered 'declining' by Town's ordinance standards.

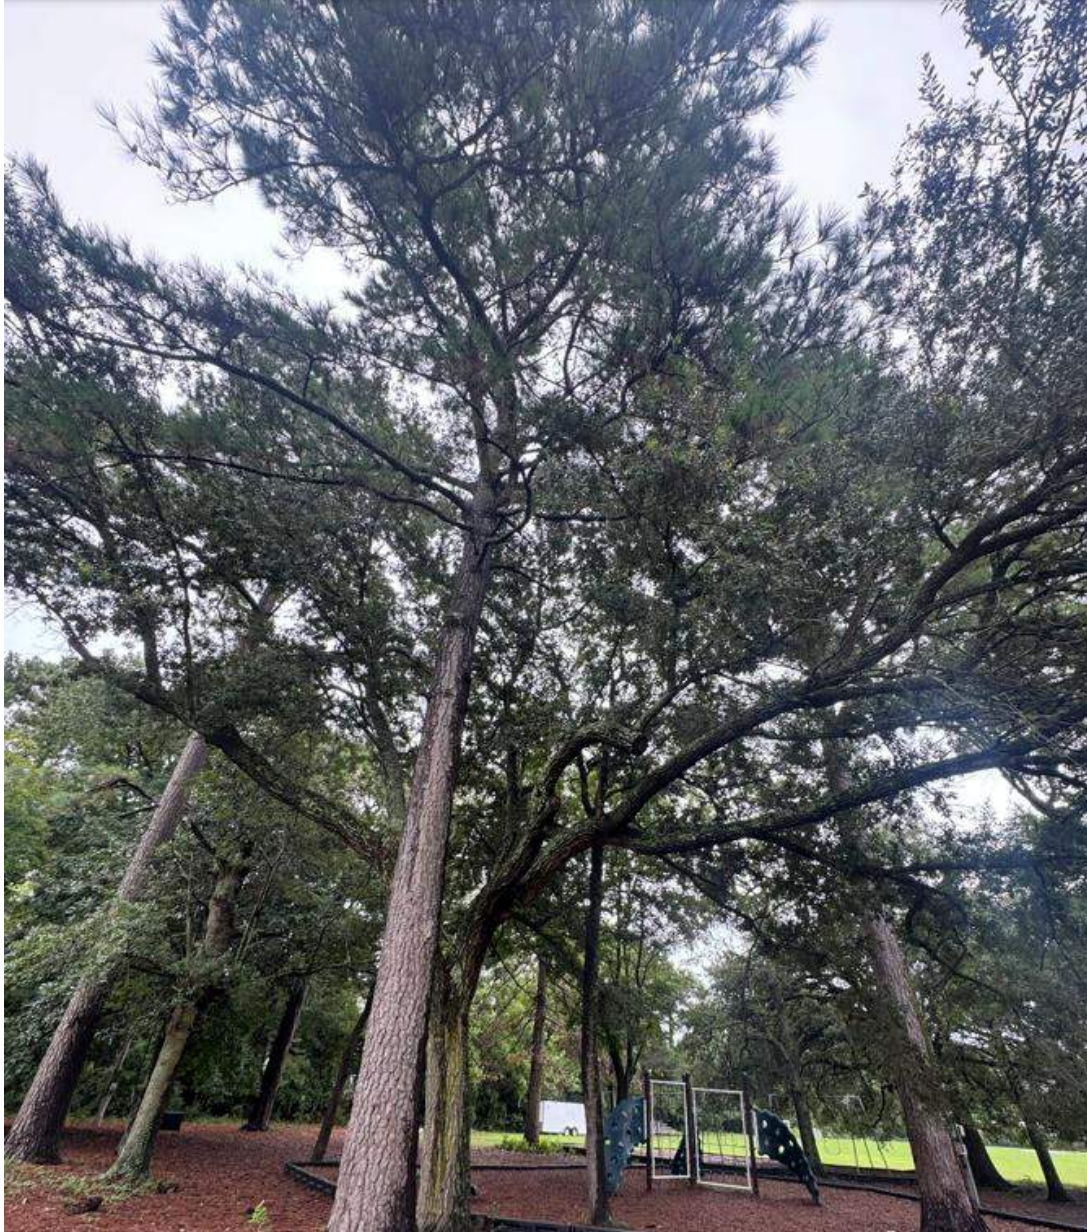
**Tree # 17**

Loblolly Pine was found to have a Live Crown Ratio between 50% and 75%, with no obvious signs of decline during inspection.

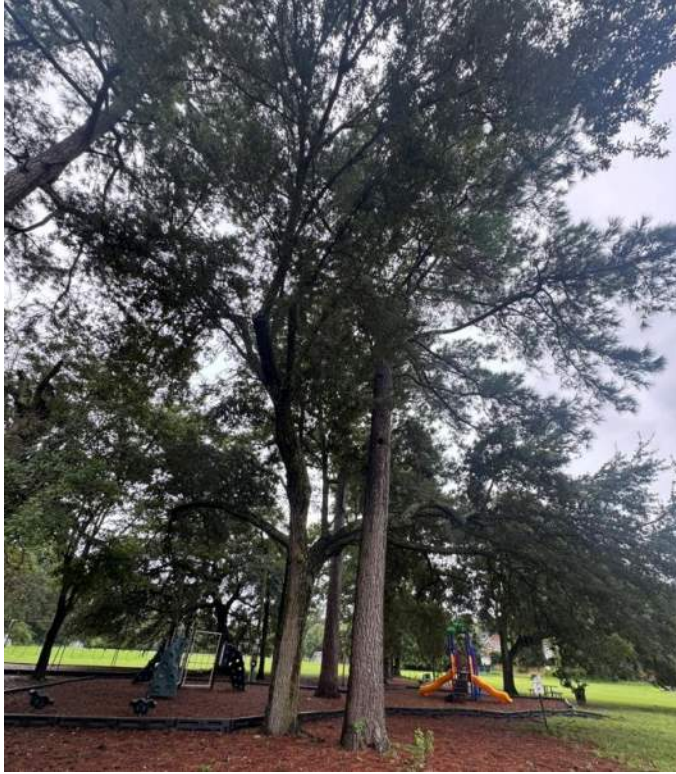
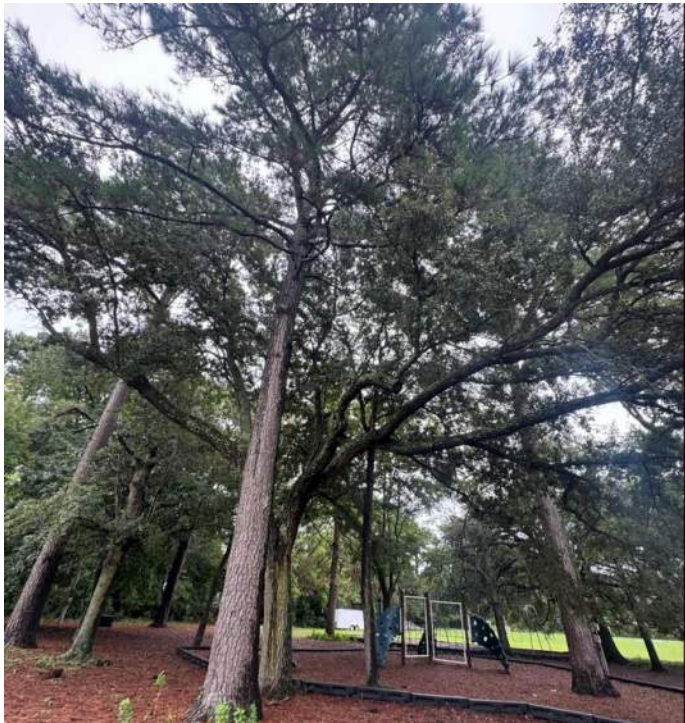
**Tree # 18**

The Live Oak has no obvious structural defects and shows a phototropic lean, but no associated heaving was observed.

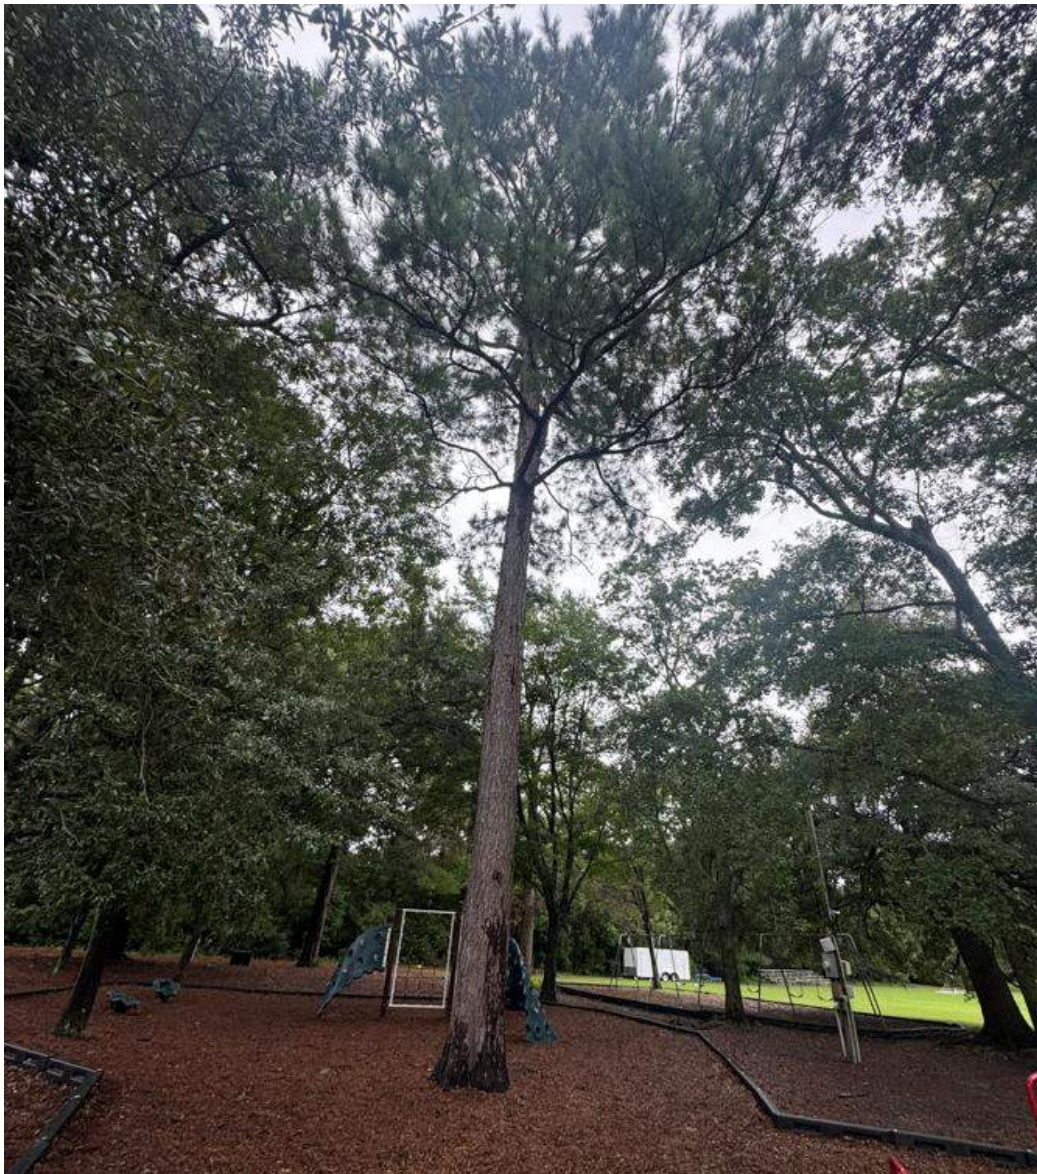
### **Tree # 19**

Loblolly Pine was observed to have a good LCR, with no obvious structural defects.

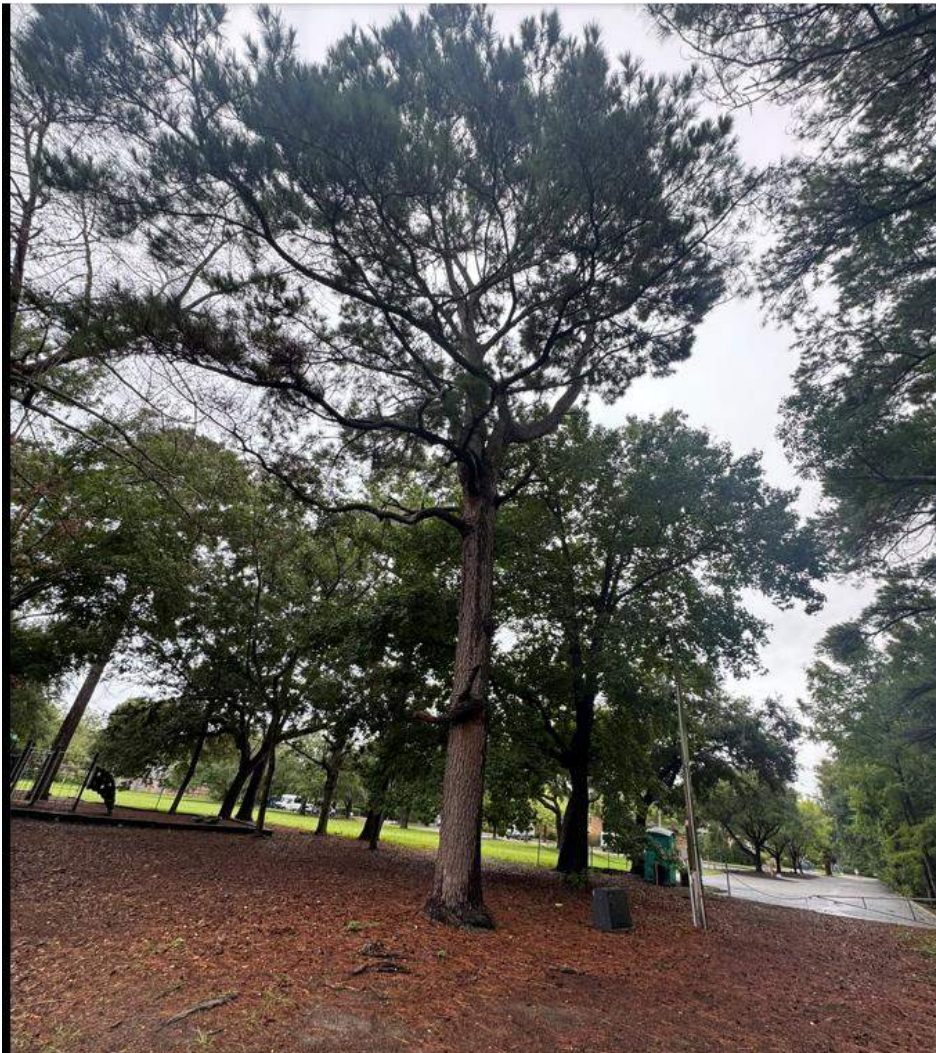
### **Tree # 20**

Loblolly Pine was observed to have a good LCR, with no obvious structural defects.

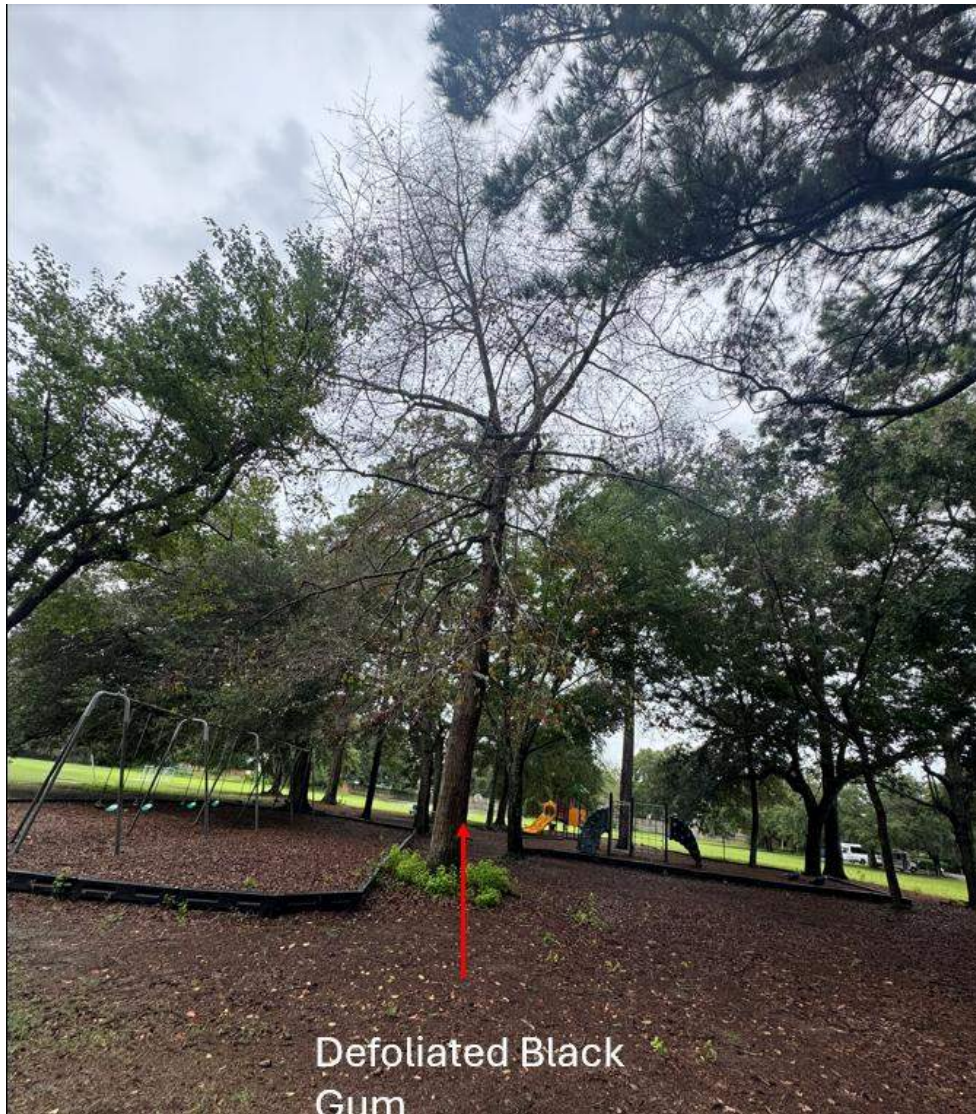
**Tree # 21**

The Black Gum was completely defoliated during inspection. The inspection occurred in late August, so the tree should be foliated. Black Gums typically lose their leaves in October.

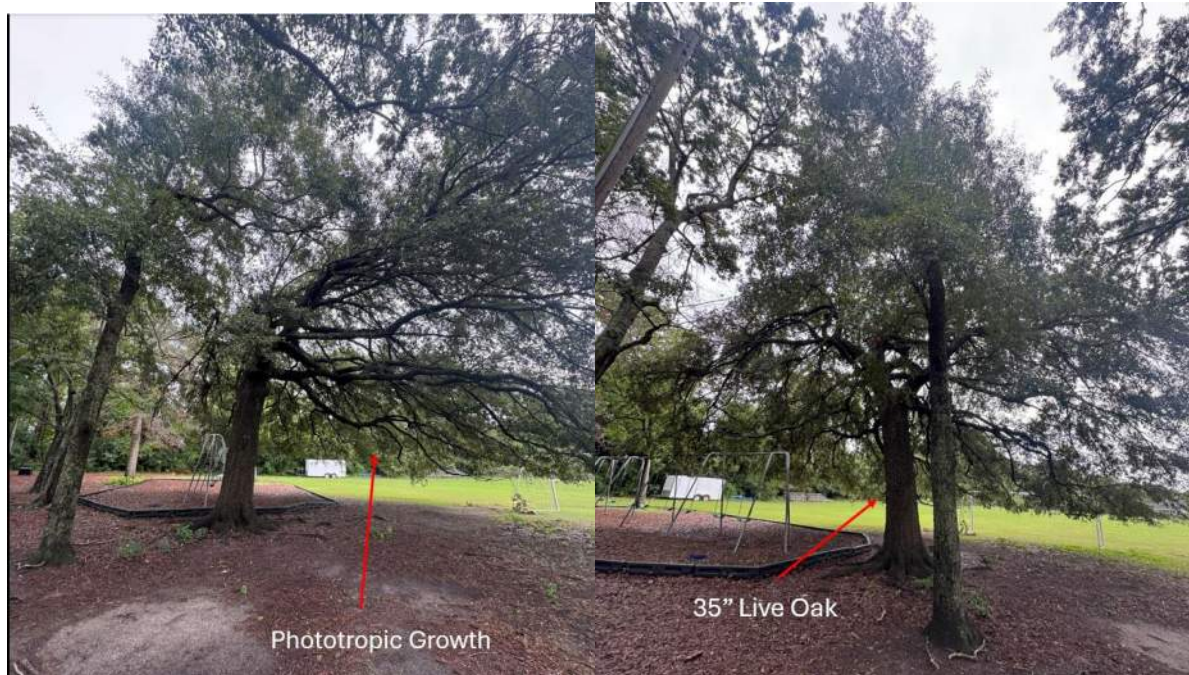
**Tree # 24**

The Live Oak had no structural defects at the time of inspection. The tree has a phototropic lean, but no heaving was associated with it.

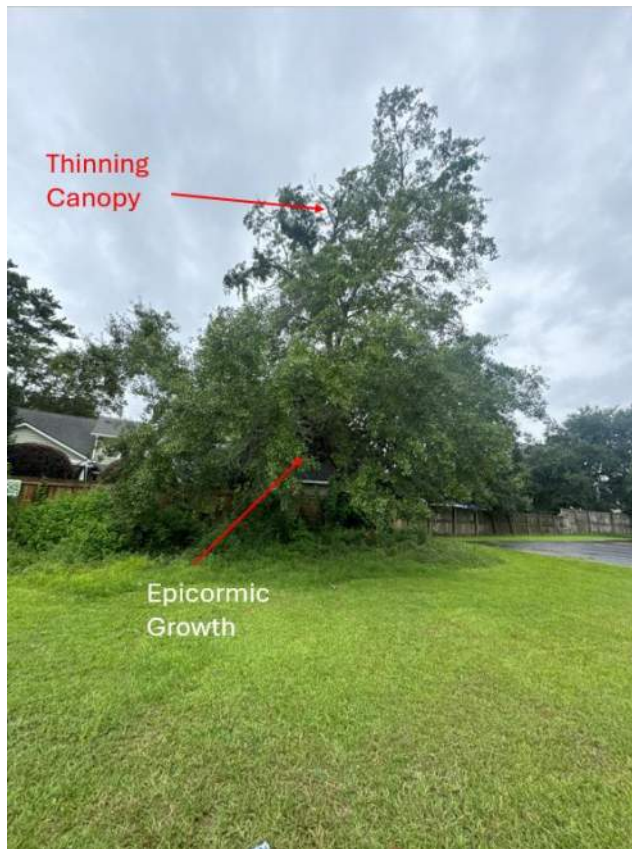
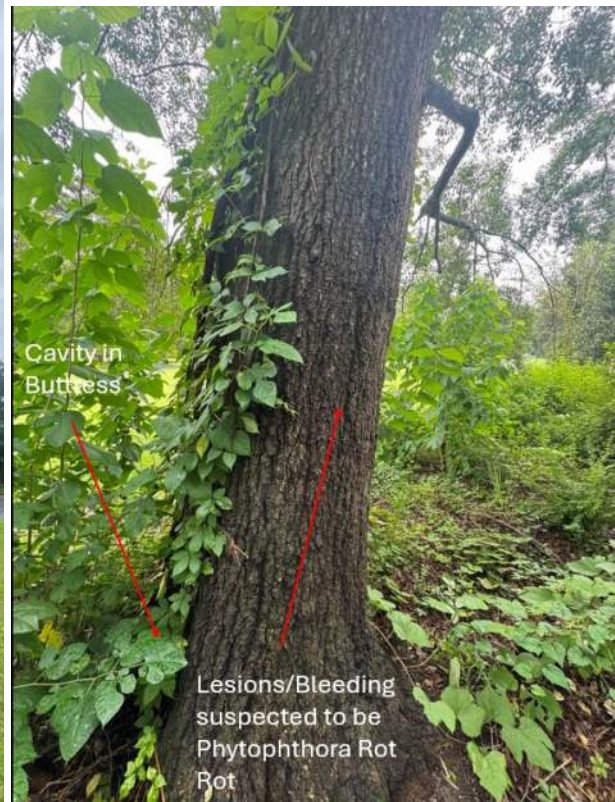
**Tree # 27**

| Tree Number | Tree Size and Species | Condition | Notes | Historic? |
|---|---|---|---|---|
| 27 | 28" Water Oak | Poor | Cavity in Buttress/ Phytophthora Root Rot | Y |

The water oak was found to contain a cavity in the buttress area, along with showing evidence of phytophthora root rot. There is no arborist intervention method for correcting a cavity at the base of a tree, and when root rot is beginning to show signs of lesions on the bark, then it's likely compromised the root growth.
